PIPE & BEAM COMPOSITE REPAIR

Project: 3 pipes & 1 set of I beam composite repair

Location: Port Dickson

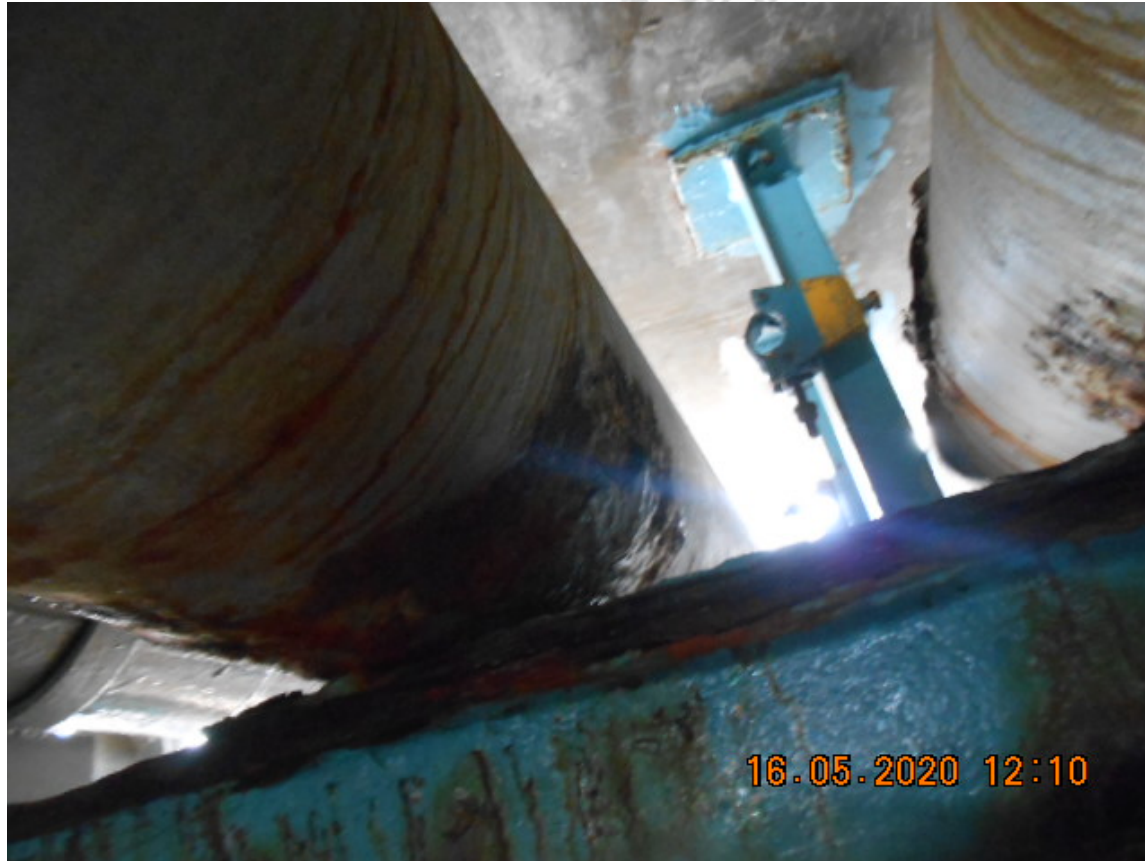
16.05.2020 12:10

Corrosion on both of the 12" pipes

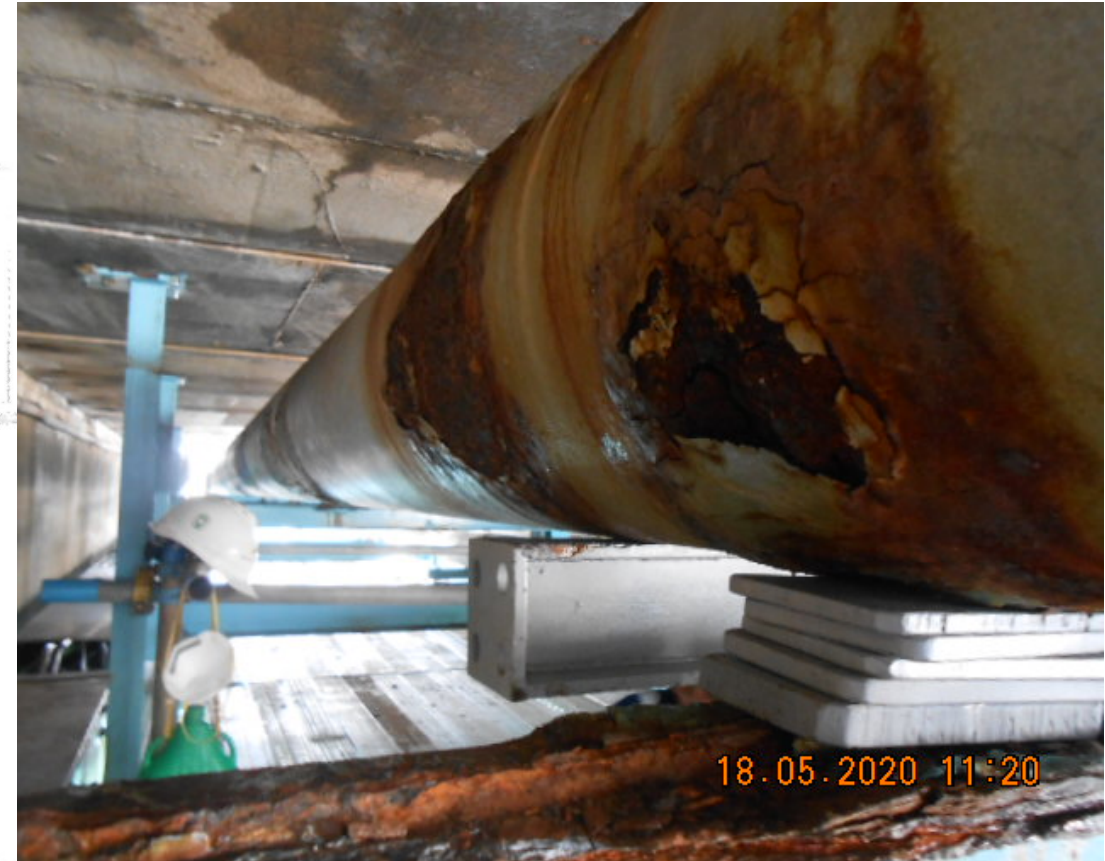
18.05.2020 11:20

Both pipes required to be wrapped at 5m and 2.4m length

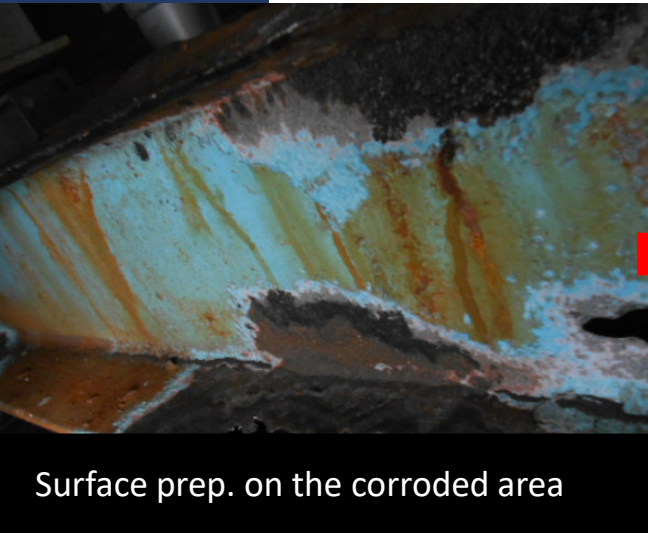
Surface prep. on the corroded area
